Inspection Report

Property Address:
1234 NW EAGLE NEST LOOP
PORTLAND, OREGON 97002

Eagle Eye Inspections

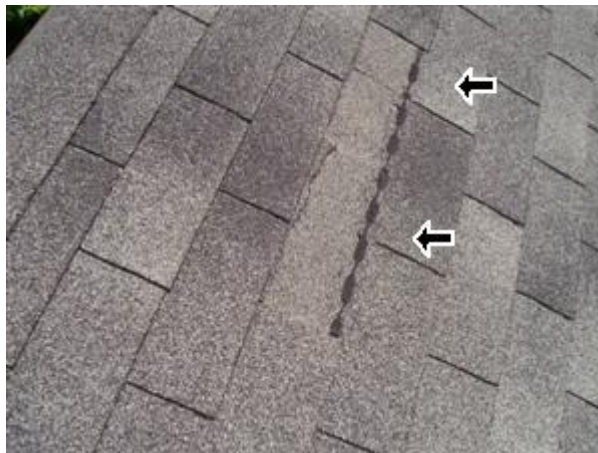
1.1 Picture 1

MISSING SHINGLE(S) AT SOUTH SIDE . (Picture 1) RECOMMEND REPLACE.

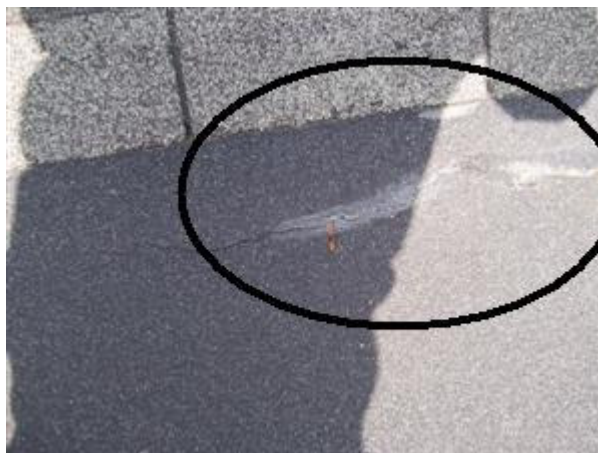
1.1 Picture 2

TORN ROOFING AT LOW SLOPE ROOF. (Picture 2) RECOMMEND REPLACE AS NECESSARY.

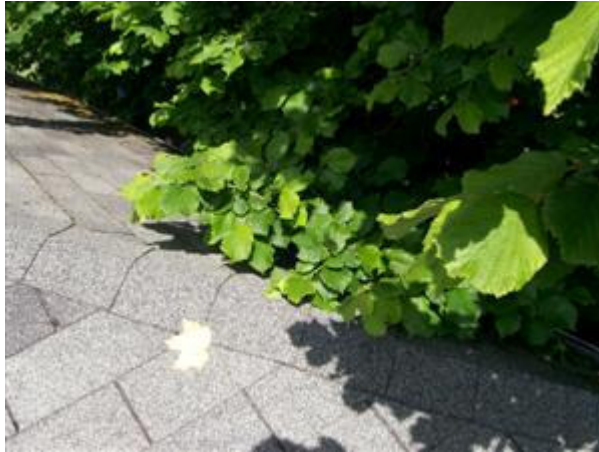
1.1 Picture 3

TREE/SHRUBS RUBBING ON ROOF.(Picture 3) RECOMMEND CUT AWAY ALL VEGETATION TO PREVENT ROOF DAMAGE.

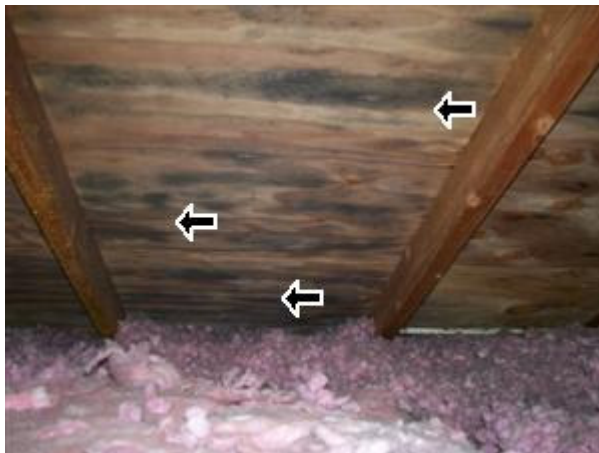
1.6 Picture 1

STAINING NOTED ON SHEATHING.(Picture 1) RECOMMEND MONITOR AND IMPROVE ATTIC VENTILATION TO HELP PREVENT MOISTURE BUILD-UP AND REDUCE MOLD GROWTH HABITAT.

STAINING NOTED ON SHEATHING.(Picture 1) RECOMMEND MONITOR AND IMPROVE ATTIC VENTILATION TO HELP PREVENT MOISTURE BUILD-UP AND REDUCE MOLD GROWTH HABITAT.

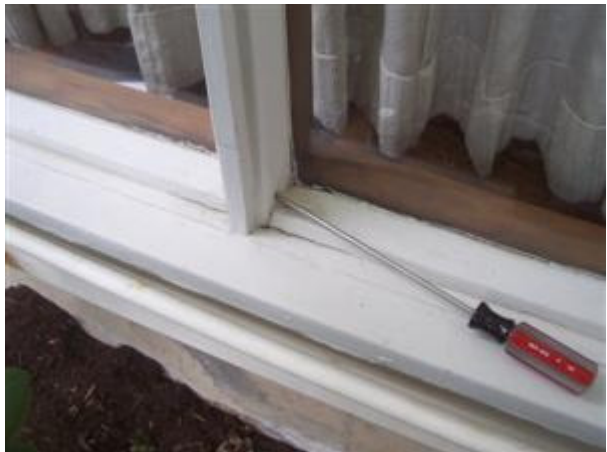
2.3 Picture 1

OLDER SINGLE GLAZED WINDOW THROUGHOUT. RECOMMEND CONSIDER UP-GRADING FOR INCREASED ENERGY SAVINGS AND HOME VALUE. DAMAGE TO WOOD SASHES/SILLS AT EAST SIDE(Picture 1) AND WEST SIDE AT REAR (Picture 2) ; RECOMMEND REMOVE ALL DAMAGED MATERIAL AND REPAIR.

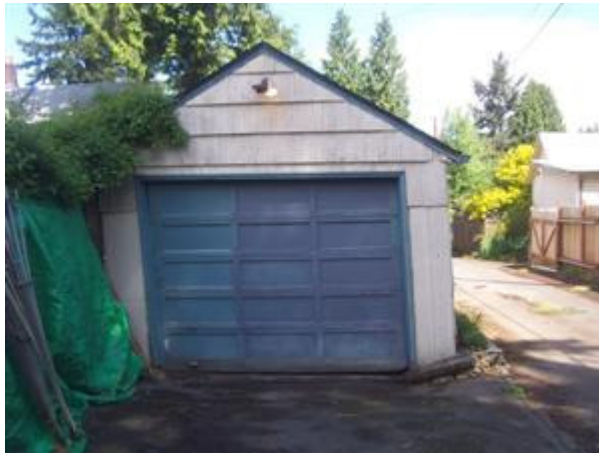
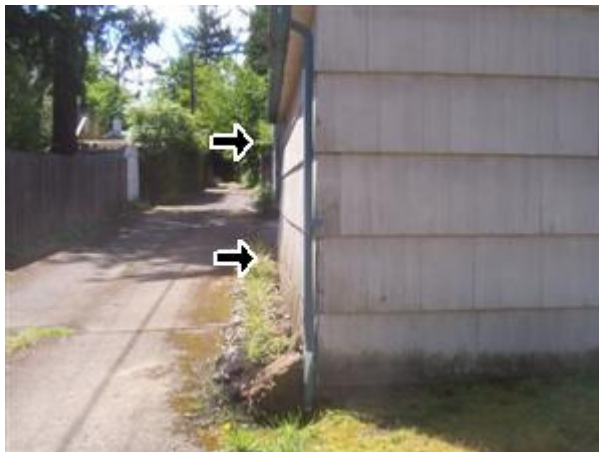
3.1 EXTERIOR (Roof/Siding/Foundation)
 BUILDING IS LEANING.(Picture 1) (Picture 2) THERE IS DAMAGE TO SIDING AND
 INTERIOR FRAMING, RECOMMEND REPLACE THE ENTIRE BUILDING.

BUILDING IS LEANING.(Picture 1) (Picture 2) THERE IS DAMAGE TO SIDING AND INTERIOR FRAMING, RECOMMEND REPLACE THE ENTIRE BUILDING.

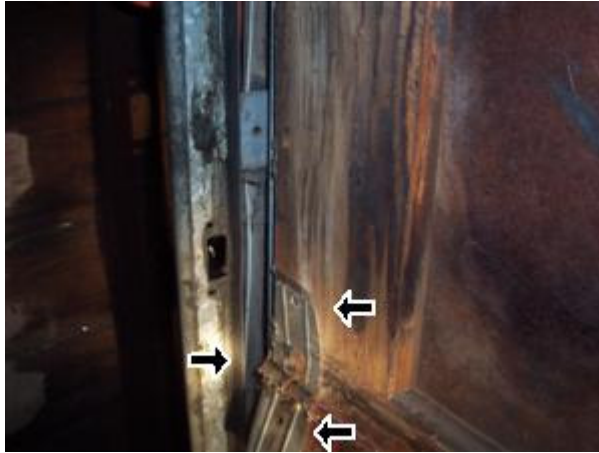
3.5 Picture 1

- 3.5 VEHICLE DOOR(S)
BROKEN ROLLER.(Picture 1) THERE IS SUCH A LEAN TO THE BUILDING AND A MISSING ROLLER I WAS NOT ABLE TO OPERATE THE DOOR.

BROKEN ROLLER.(Picture 1) THERE IS SUCH A LEAN TO THE BUILDING AND A MISSING ROLLER I WAS NOT ABLE TO OPERATE THE DOOR.

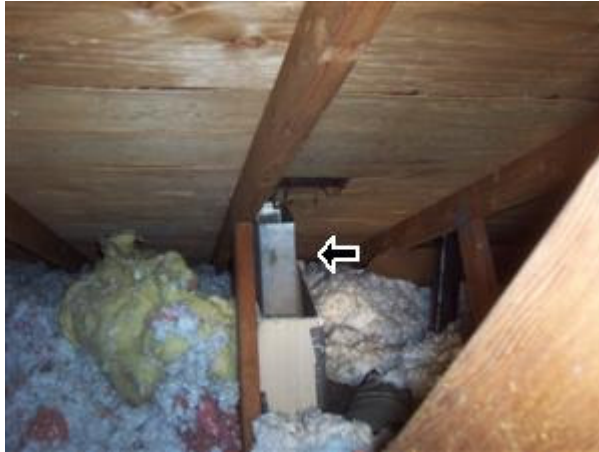
4.9 Picture 1

FAN IS VENTING INTO THE ATTIC.(Picture 1) RECOMMEND REDIRECT TO OUTSIDE.

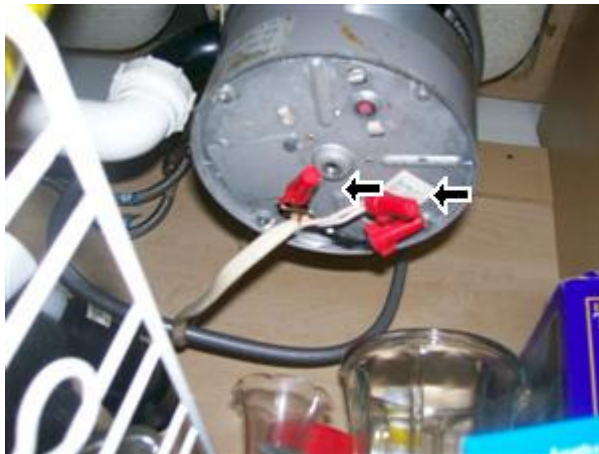
4.10 Picture 1

DISPOSER: IN SINK ERATOR
MISSING PROPER CONNECTION AT WIRE/PLUG TO UNIT. (Picture 1) RECOMMEND
ELECTRICIAN CORRECT AS REQUIRED.

MISSING PROPER CONNECTION AT WIRE/PLUG TO UNIT. (Picture 1) RECOMMEND ELECTRICIAN CORRECT AS REQUIRED.

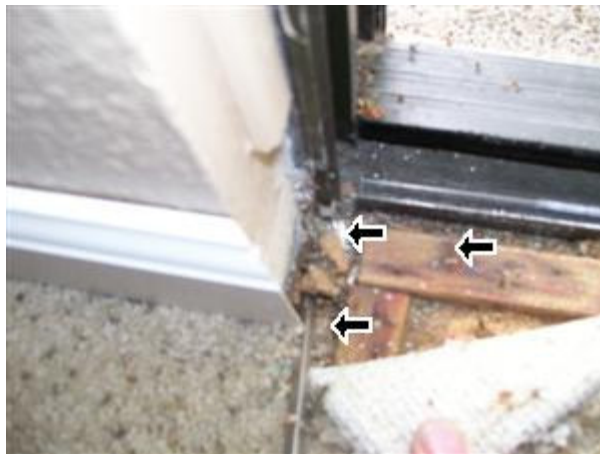
5.3.C Picture 1

<input type="checkbox"/>	<input type="checkbox"/>	<input type="checkbox"/>	<input checked="" type="checkbox"/>	5.3.C FLOORS FLOORS: CARPETS ROT DAMAGE AT REAR SLIDER. RECOMMEND REMOVE ALL DAMAGED MATERIALS AND REPAIR TORN CARPETS.
--------------------------	--------------------------	--------------------------	-------------------------------------	--

ROT DAMAGE AT REAR SLIDER. RECOMMEND REMOVE ALL DAMAGED MATERIALS AND REPAIR TORN CARPETS.

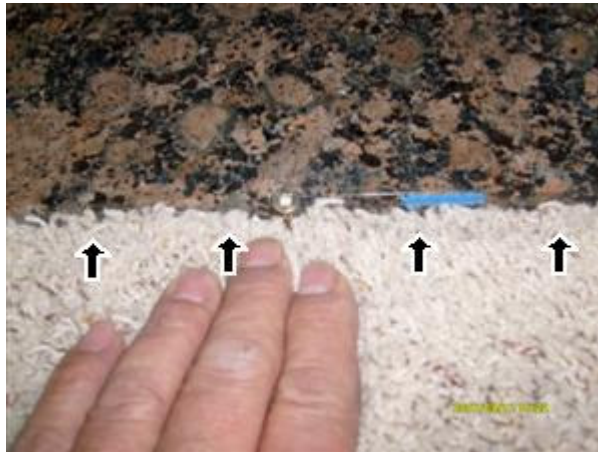
5.3.D Picture 1

5.3.D FLOORS
FLOORS: CARPETS
 SHARP TILE EDGE AT TRANSITION OF HALL BATHROOM IS EXPOSED. (Picture 1) THIS IS A TRIP HAZARD AND UNCOMFORTABLE TO STEP ON. RECOMMEND CORRECT AS NECESSARY.

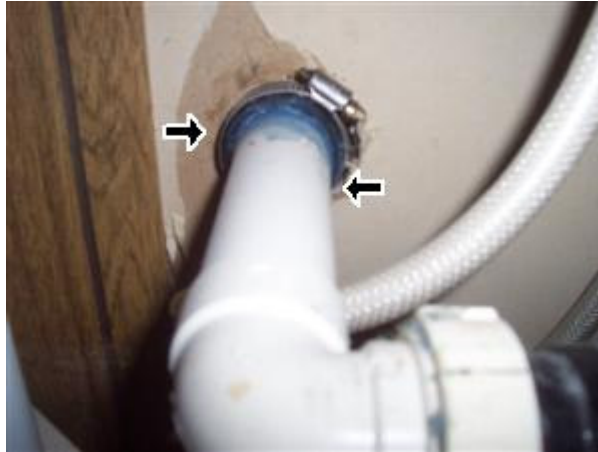
6.1.A Picture 1

<input type="checkbox"/>	<input type="checkbox"/>	<input type="checkbox"/>	<input checked="" type="checkbox"/>	6.1.A SINK SINK DRAIN CONNECTION NOT CORRECT AT WALL. CAULK USED TO SEAL DRAIN LINE. RECOMMEND REPAIR/REPLACE PLUMBING TO PREVENT LEAKING.
--------------------------	--------------------------	--------------------------	-------------------------------------	---

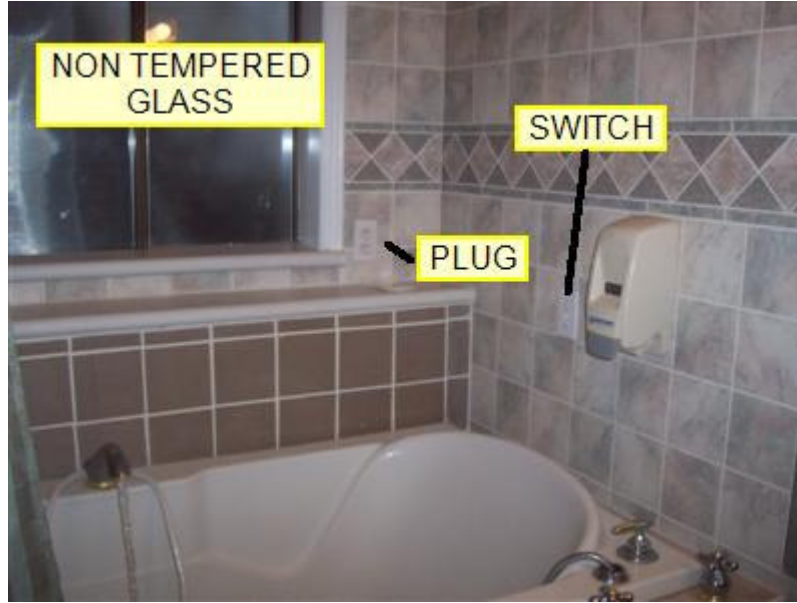
6.4.A Picture 1

<input type="checkbox"/>	<input type="checkbox"/>	<input type="checkbox"/>	<input checked="" type="checkbox"/>	6.4.A BATHTUB WINDOW AT TUB IS NOT TEMPERED. PLUG AND SWITCHES ARE INSTALLED TOO CLOSE TO THE TUB. THIS ELECTRICIAN WORK WAS NOT PERMITTED. RECOMMEND FURTHER EVALUATION BY LICENSED ELECTRICIAN.
--------------------------	--------------------------	--------------------------	-------------------------------------	--

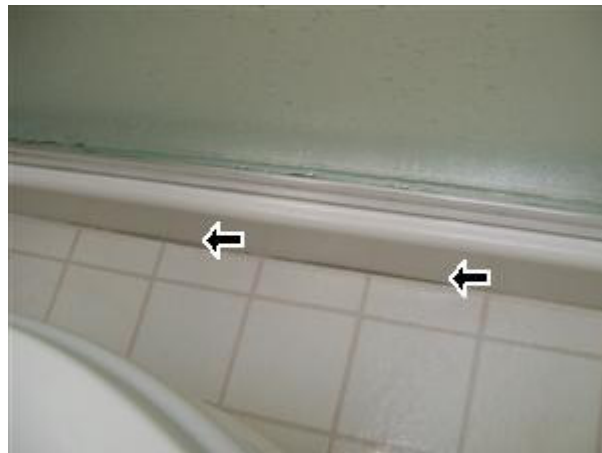
6.6.B Picture 1

<input type="checkbox"/>	<input type="checkbox"/>	<input type="checkbox"/>	<input checked="" type="checkbox"/>	6.6.B FLOORS CRACKED/MISSING CAULK AT FLOOR TO SHOWER.(Picture 1) RECOMMEND REMOVE OLD /LOOSE CAULK AND RESEAL AS NECESSARY. THIS IS A MAINTENANCE ITEM AND SHOULD BE CHECKED MONTHLY.

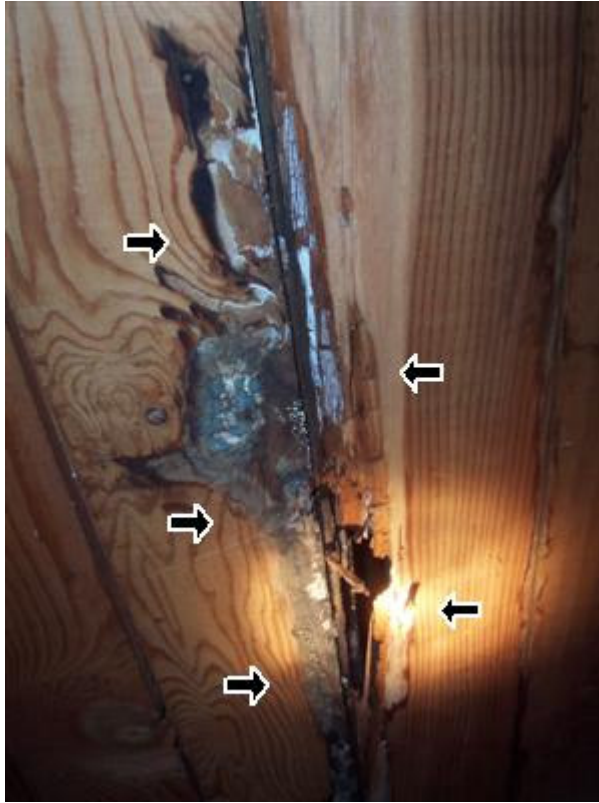
7.4 Picture 1

<input type="checkbox"/>	<input type="checkbox"/>	<input type="checkbox"/>	<input checked="" type="checkbox"/>	7.4 FLOORS FRAMING FLOOR STRUCTURE: 2 X 8, W/ 2X6 DECKING, W/ SHIP LAPPED WOOD DAMAGE FROM WOOD DISTORTING INSECTS OR FUNGUS ROT UNDER THE MASTER BATHROOM SHOWER. RECOMMEND REMOVE ALL DAMAGED MATERIALS AND TREAT FOR INFESTERS AS NECESSARY.

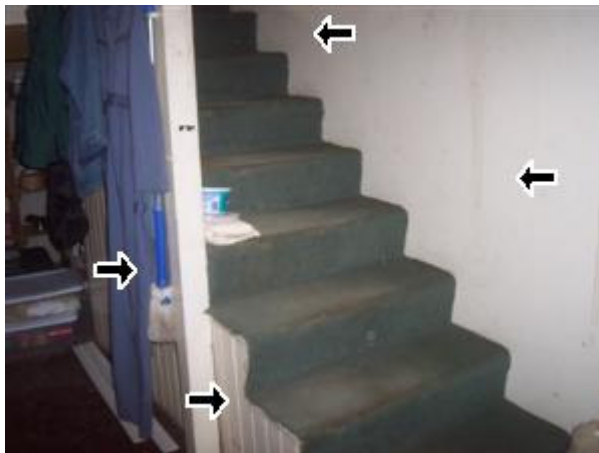
7.6 Picture 1

FLOOR INSULATION: UNFACED, BATTS
MISSING GUARD RAIL AT OPEN STAIRS. (Picture 1)RECOMMEND INSTALL.

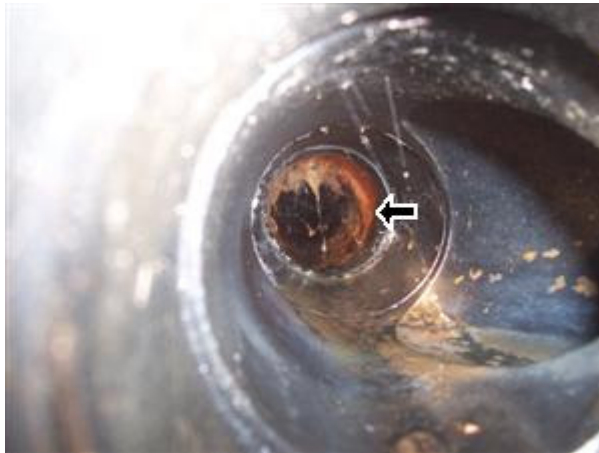
8.1 Picture 1

8.1 INTERIOR DRAIN, WASTE AND VENT SYSTEMS
PLUMBING WASTE: CAST IRON, ABS
 DUE TO AGE OF SYSTEM IT IS ADVISED THAT A SEWER LINE INSPECTION BE PERFORMED BEFORE CLOSING TO ASSES THE CONDITION OF THE LINE FROM THE HOUSE T THE MAIN CITY SEWER HOOK-UP. SUSPECT SOME DAMAGE FROM THE BACK-UP AT THE BATHTUB. PICTURES #1 & #2 ARE OF INSIDE OF THE WASTE LINE IN THE CRAWL SPACE. AS SEEN THERE IS DEBRIS AND OR DISPLACEMENT DOWN THE LINE.

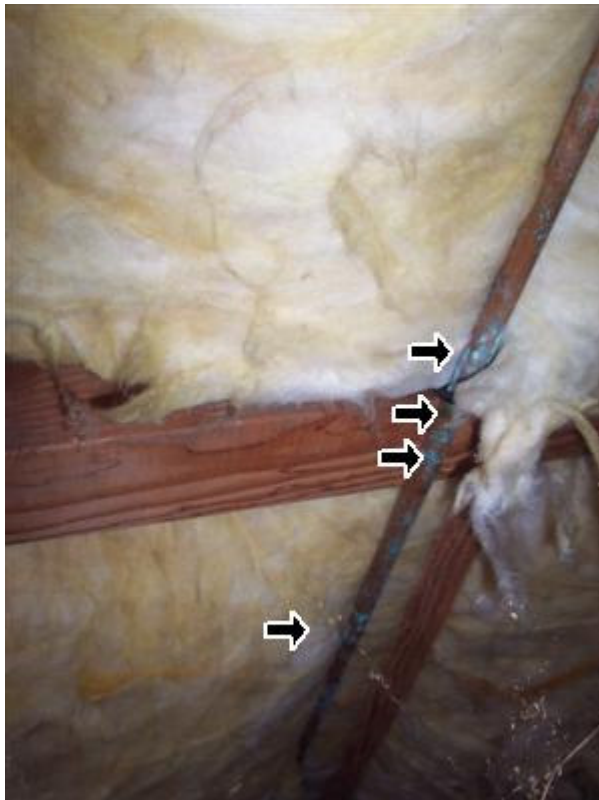
8.2 Picture 1

WATER SUPPLY: PUBLIC
WATER SUPPLY PIPE: MIXED, COPPER/GALVANIZED
FLEX PASTE RESIDUE IS PRESENT ON COPPER PLUMBING.(Picture 1) THIS IS CAUSING CORROSION TO THE PIPES. RECOMMEND CLEAN WITH SOAPY WATER TO STOP THE PROCESS. COPPER TO GALVANIZED CONNECTIONS AT S/W BASEMENT ;(Picture 3)
RECOMMEND PLUMBER CORRECT AS REQUIRED.

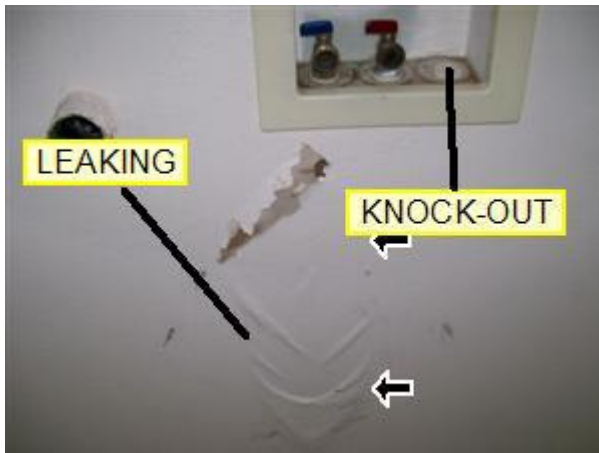
8.4 Picture 1

8.4 LAUNDRY ROOM/AREA
EVIDENCE OF LEAKAGE AT WASHER HOOK-UP. ALSO THE KNOCK-OUT FOR THE WASHER DRAIN HAS NOT BEEN REMOVED. RECOMMEND PLUMBER REMOVE KNOCK-OUT, IDENTIFY AND ADDRESS LEAKING ISSUE.

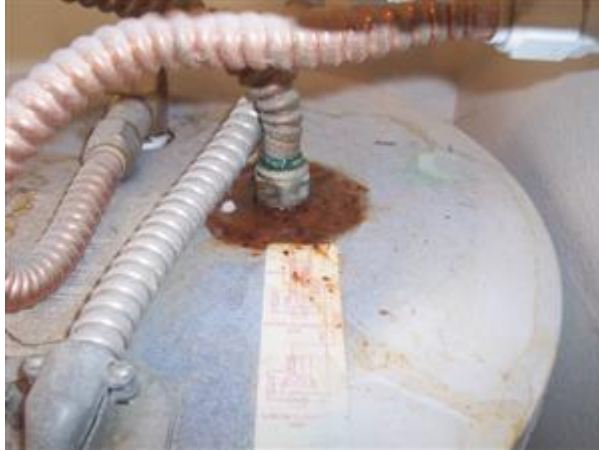
8.7 Picture 1

8.7 WATER HEATER
 FUNCTIONING HOWEVER WELL BEYOND DESIGN LIFE EXPECTATIONS. RUSTING AT
 SUPPLY LINES. ANTICIPATE REPLACEMENT. MISSING SEISMIC RESTRAINTS.
 RECOMMEND INSTALL AS REQUIRED.

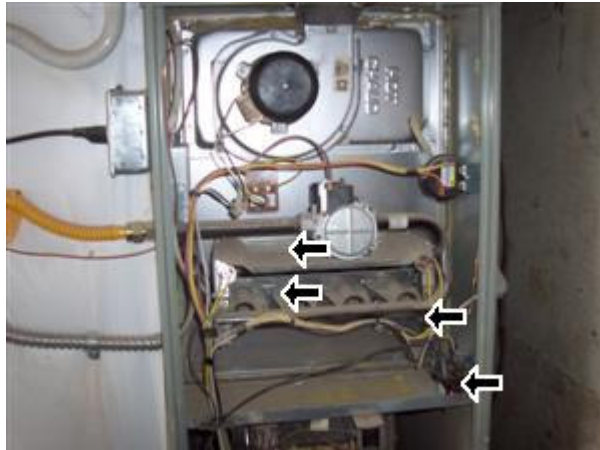
10.1 Picture 1

NO SIGNS OF PREVIOUS SERVICE.(Picture 1) RECOMMEND QUALIFIED CONTRACTOR SERVICE. SERVICE SHOULD BE DONE ANNUALLY

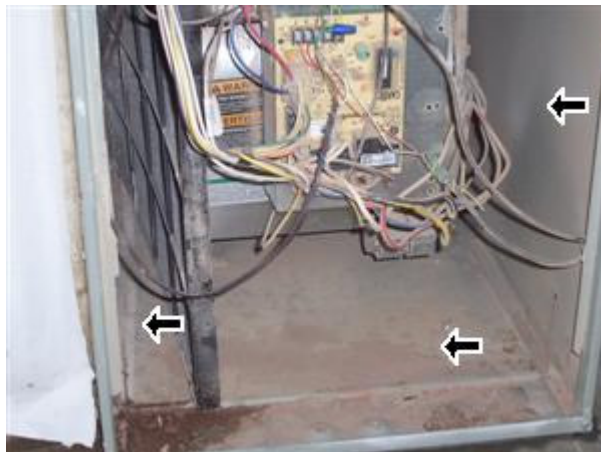
10.4 Picture 1

10.4 BLOWER/FILTERS
 BLOWER COMPARTMENT IS HEAVILY COATED WITH DUST.(Picture 1) RECOMMEND CLEANING.
