Inspection Report

Property Address:
1234 NW EAGLE NEST LOOP
PORTLAND, OREGON 97002

Eagle Eye Inspections

Date: 7/29/2007	Time: 11:59 AM	Report ID: 12345
Property: 1234 NW EAGLE NEST LOOP PORTLAND, OREGON 97002	Customer: YOUR NAME	Real Estate Professional: YOUR AGENT HERE

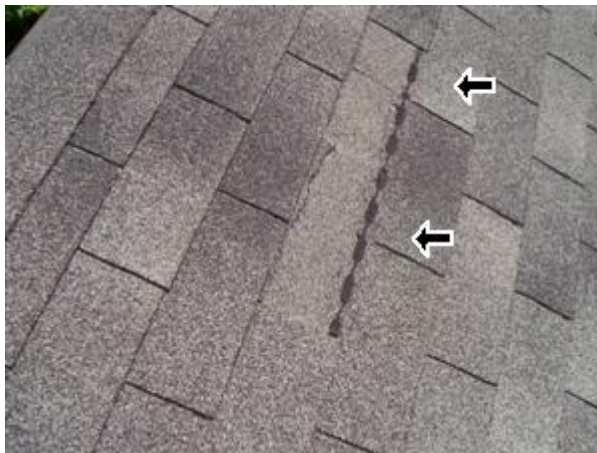
1.1 Picture 1

MISSING SHINGLE(S) AT SOUTH SIDE . (Picture 1) RECOMMEND REPLACE.

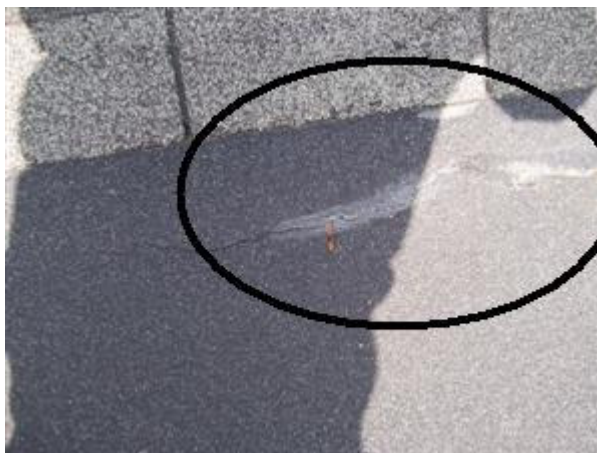
1.1 Picture 2

TORN ROOFING AT LOW SLOPE ROOF. (Picture 2) RECOMMEND REPLACE AS NECESSARY.

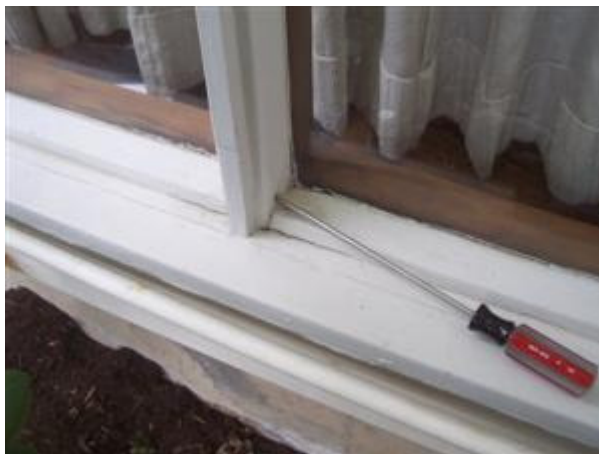
2.3 Picture 1

OLDER SINGLE GLAZED WINDOW THROUGHOUT. RECOMMEND CONSIDER UP-GRADING FOR INCREASED ENERGY SAVINGS AND HOME VALUE. DAMAGE TO WOOD SASHES/SILLS AT EAST SIDE(Picture 1) AND WEST SIDE AT REAR (Picture 2) ; RECOMMEND REMOVE ALL DAMAGED MATERIAL AND REPAIR.

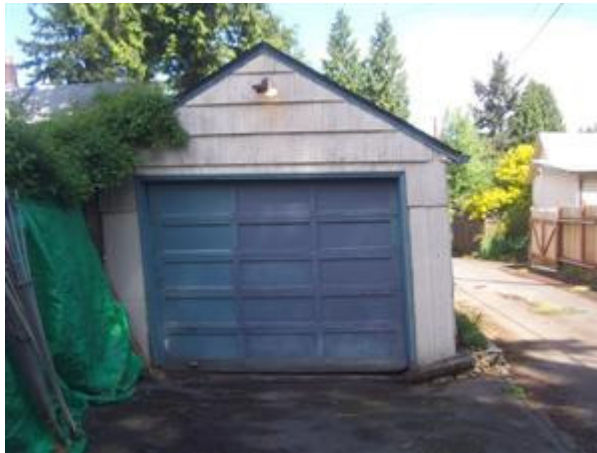
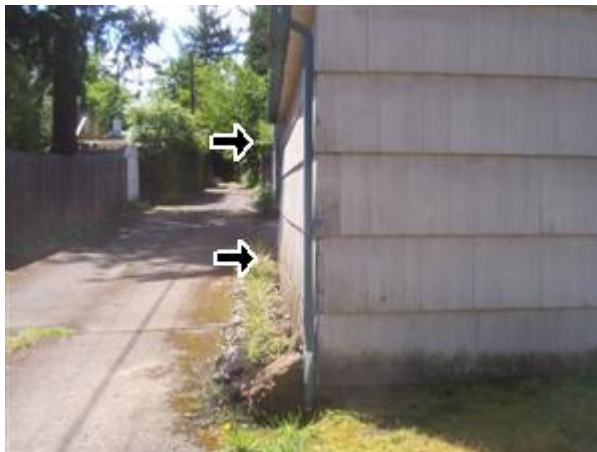
3.1 Picture 1

3.1 EXTERIOR (Roof/Siding/Foundation)
 BUILDING IS LEANING.(Picture 1) (Picture 2) THERE IS DAMAGE TO SIDING AND INTERIOR FRAMING, RECOMMEND REPLACE THE ENTIRE BUILDING.

BUILDING IS LEANING.(Picture 1) (Picture 2) THERE IS DAMAGE TO SIDING AND INTERIOR FRAMING, RECOMMEND REPLACE THE ENTIRE BUILDING.

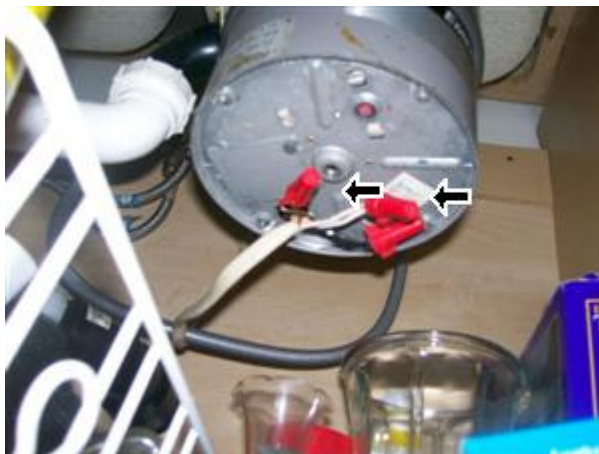
4.10 Picture 1

4.10 DISPOSAL
DISPOSER: IN SINK ERATOR
MISSING PROPER CONNECTION AT WIRE/PLUG TO UNIT. (Picture 1) RECOMMEND
ELECTRICIAN CORRECT AS REQUIRED.

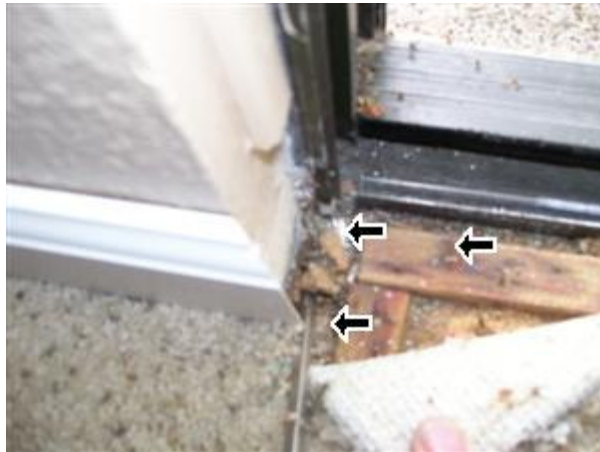
5.3.C Picture 1

5.3.C FLOORS
FLOORS: CARPETS
ROT DAMAGE AT REAR SLIDER. RECOMMEND REMOVE ALL DAMAGED MATERIALS AND REPAIR TORN CARPETS.

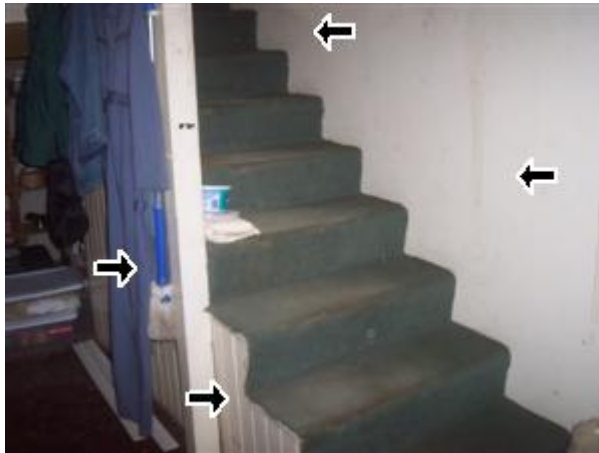
7.6 Picture 1

FLOOR INSULATION: UNFACED, BATTS
MISSING GUARD RAIL AT OPEN STAIRS. (Picture 1)RECOMMEND INSTALL.

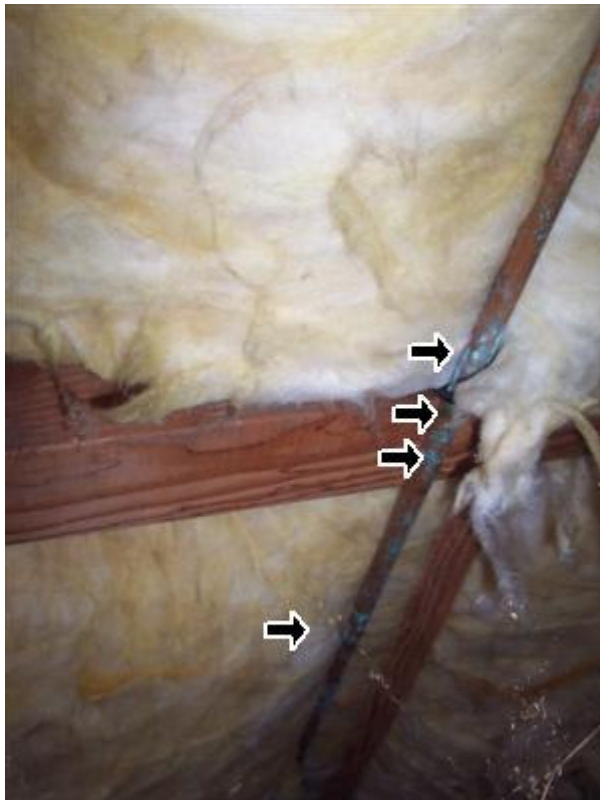
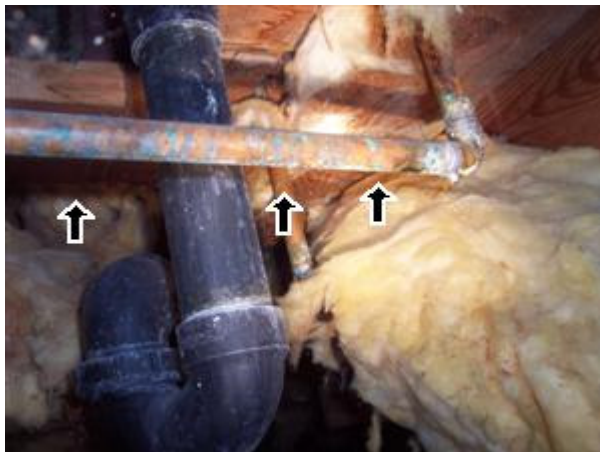
8.2 Picture 1

FLEX PASTE RESIDUE IS PRESENT ON COPPER PLUMBING.(Picture 1) THIS IS CAUSING CORROSION TO THE PIPES. RECOMMEND CLEAN WITH SOAPY WATER TO STOP THE PROCESS. COPPER TO GALVANIZED CONNECTIONS AT S/W BASEMENT ;(Picture 3) RECOMMEND PLUMBER CORRECT AS REQUIRED.

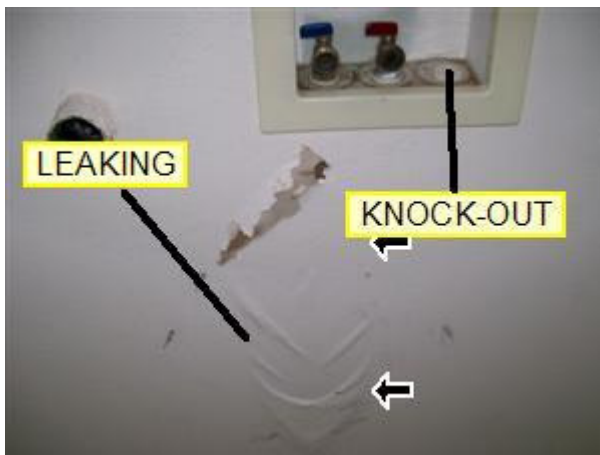
8.4 Picture 1

8.4 LAUNDRY ROOM/AREA
EVIDENCE OF LEAKAGE AT WASHER HOOK-UP. ALSO THE KNOCK-OUT FOR THE WASHER DRAIN HAS NOT BEEN REMOVED. RECOMMEND PLUMBER REMOVE KNOCK-OUT, IDENTIFY AND ADDRESS LEAKING ISSUE.

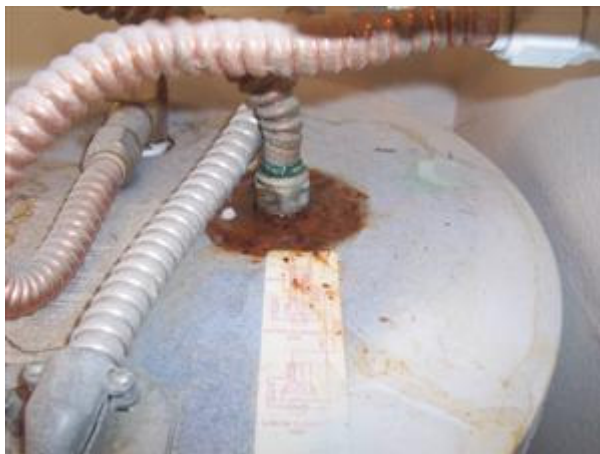
8.7 Picture 1

8.7 WATER HEATER
 FUNCTIONING HOWEVER WELL BEYOND DESIGN LIFE EXPECTATIONS. RUSTING AT
 SUPPLY LINES. ANTICIPATE REPLACEMENT. MISSING SEISMIC RESTRAINTS.
 RECOMMEND INSTALL AS REQUIRED.
